Blue Lion Home Inspections Inc.

Property Inspection Report

**Property address: 123 Anywhere Street
Toronto, ON A1B 2C3**

Inspection date: **Wednesday, April 6, 2022**

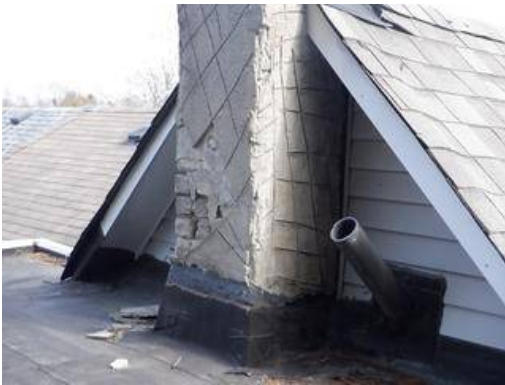
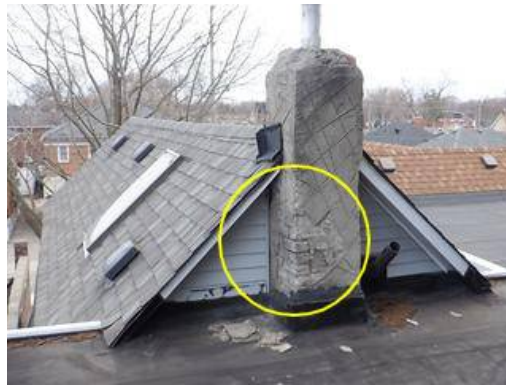
2) Repair/Replace - Chimney - Deteriorated Bricks:

- **Observation / Condition:** The brick chimney was observed to be deteriorated at time of inspection. For example, loose or missing mortar, cracked, broken, loose or spalled bricks.
- **Concern:** Loose bricks can pose a safety hazard, and deteriorated masonry can allow water to infiltrate the chimney structure and cause further damage.
- **Recommendation:** A qualified chimney contractor should repair.

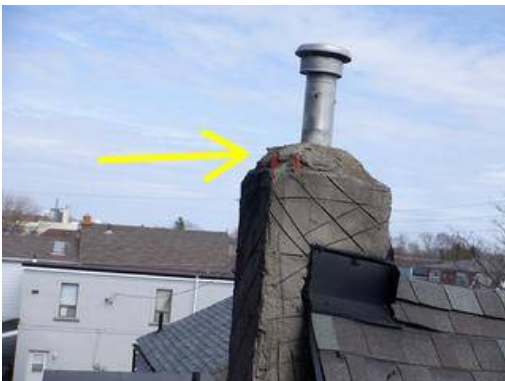
Photo 3-1

3) Recommendation - Chimney Crown - Damaged :

- **Observation / Condition:** The chimney crown was damaged at the time of inspection.
- **Concern:** This is important to protect from moisture intrusion and to protect the chimney.
- **Recommendation:** A qualified roofer or chimney expert should further evaluate.

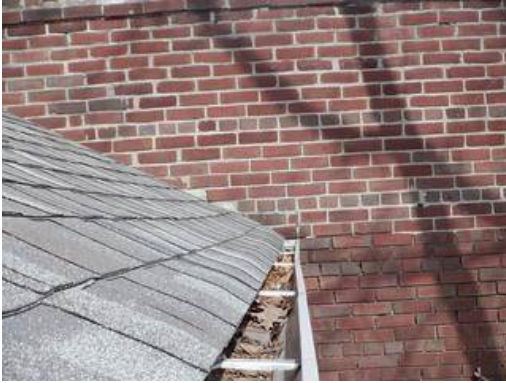
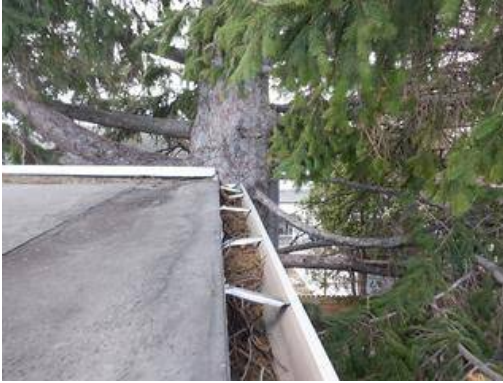
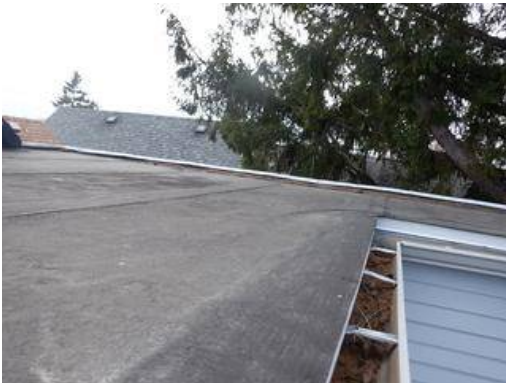
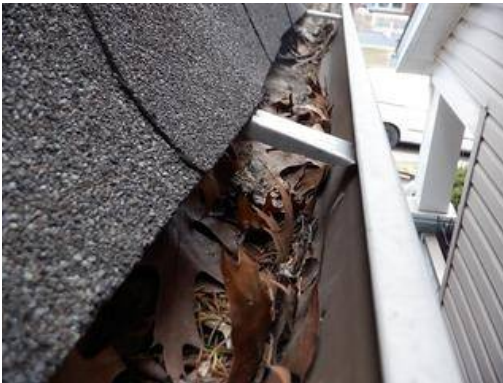
4) Recommendation - Debris in Gutters:

- **Observation / Condition:** Debris and/or leaves were accumulated in one or more gutters at the time of inspection.
- **Concern:** It can impede the flow of water towards the downspouts allowing water to back up into the shingles and into the roof structure causing damage.
- **Recommendation:** Recommend cleaning gutters and downspouts by a professional gutter cleaning company now and as necessary in the future to facilitate water flow.

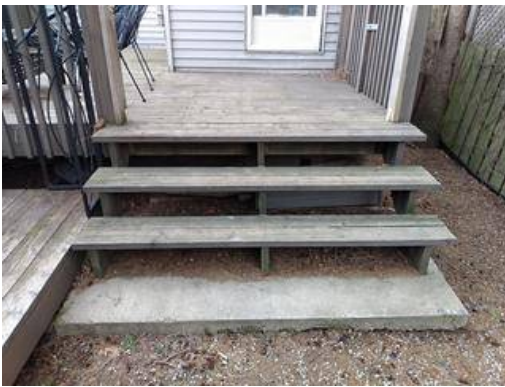
Photo 6-1 Rear Deck

6) Safety, Repair/Replace - Missing Handrails:

- **Observation / Condition:** Handrails were missing at the time of inspection. Handrails should be installed at stairs with 3 or more risers.
- **Location :** Exterior Front and Rear
- **Concern:** Fall hazard.
- **Recommendation:** A qualified contractor should install.

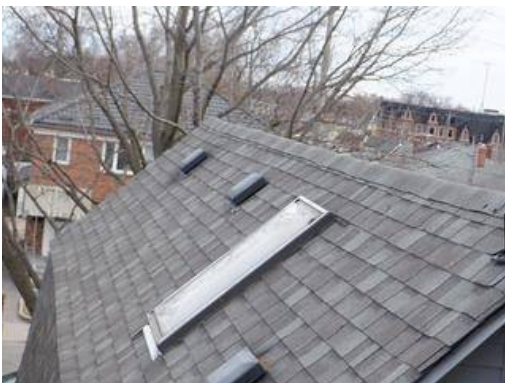
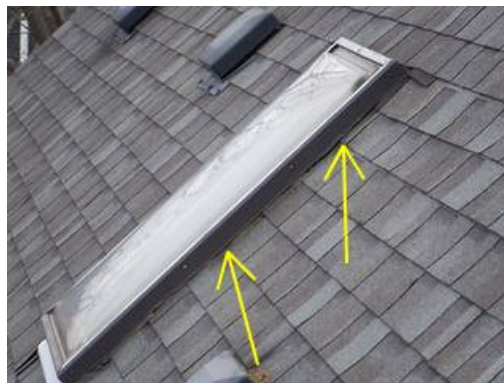
7) Repair/Replace, Recommendation - Substandard Flashing / Sealing - Skylight:

- **Observation / Condition:** There was no indication of leaks at the time of inspection, but the flashings and sealing around the skylight were substandard.
- **Location:** Upper Roof - Right Side (when facing the house)
- **Concern:** If not properly installed & sealed, they are prone to leaking and can cause damage.
- **Recommendation:** Monitor going forward. If leaks are observed, a qualified roofing contractor should further repair and improve.

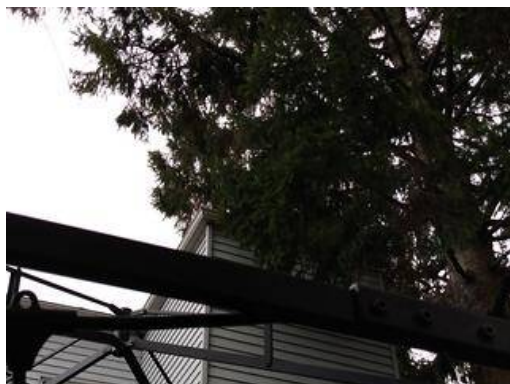
Photo 8-1

8) Recommendation - Overhanging Tree Branches:

- **Observation / Condition:** Large trees near the house had limbs / branches that overhang the home at the time of inspection.
- **Concern:** Can cause damage to the roof and clog the gutters.
- **Recommendation:** Consider having these trees trimmed.

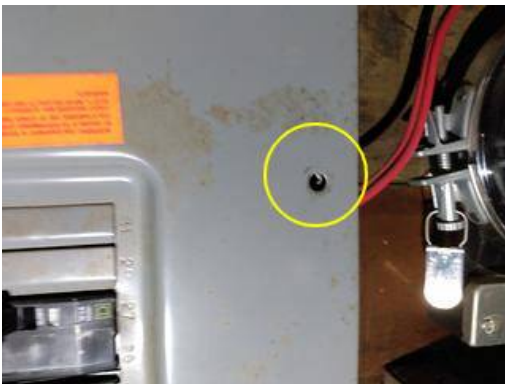
Photo 11-1 Top Right

11) **Safety, Repair/Replace** - Missing Screws - Main Service Panel:

- **Observation / Condition:** Missing screws were observed at the main service panel at the time of inspection.
- **Concern:** This can pose as a shock hazard and chance of cover falling off.
- **Recommendation:** A licensed electrician to repair.

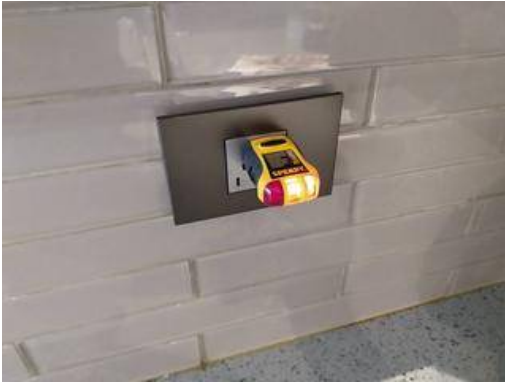
Photo 12-1

12) **Safety, Repair/Replace** - Open Ground (Not Grounded):

- **Observation / Condition:** A 3-slot electric receptacle (outlet) was found with an open ground at the time of inspection. An open ground is when you have a three-prong outlet that is not "Grounded". Grounding is now required for safety reasons.
- **Location:** Kitchen (to the right of the stove)
- **Concern:** Electric Shock Hazard
- **Recommendation:** A licensed electrician should repair.

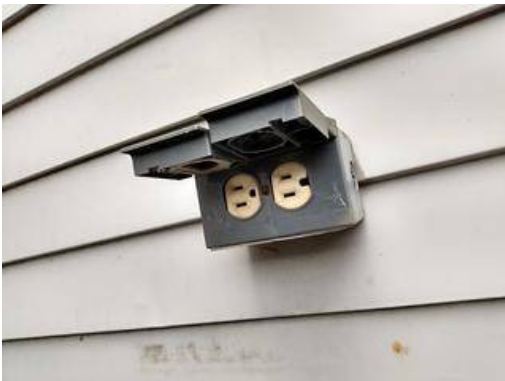
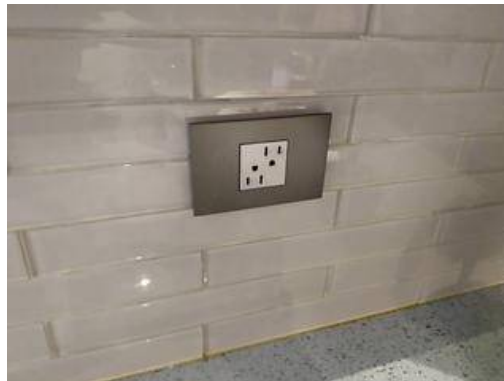
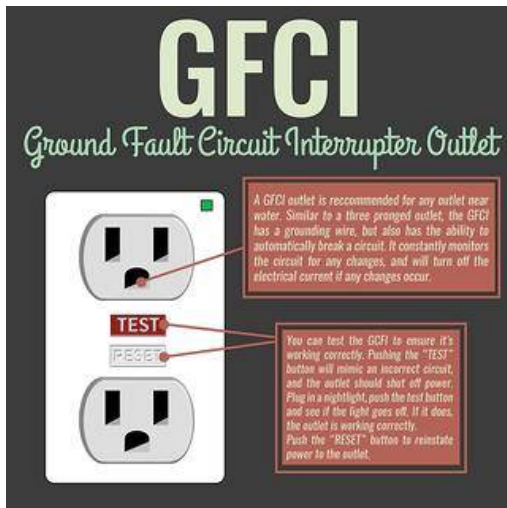
13) Safety, Repair/Replace - Missing GFCI:

- **Observation / Condition:** Receptacles (Outlets) worked at the time of inspection, but had no visible ground fault circuit interrupter (GFCI) protection or the inspector was unable to determine if GFCI was present at the time of inspection.
- **Locations:** Exterior and Kitchen.
- **Concern:** Shock hazard.
- **Recommendation:** A licensed electrician should install GFCI Receptacle.

Although this condition may have been considered acceptable at the time this house was built, it is a recommendation to upgrade because of safety reasons.

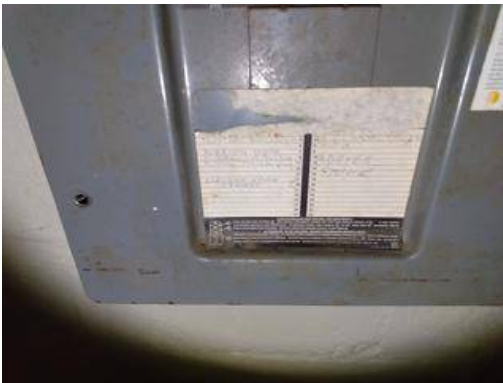
Photo 14-1

14) **Recommendation, Maintain** - Legend - Missing / Substandard:

- **Observation / Condition:** The legend for the circuit breakers at the service panel(s) were missing, incomplete, illegible or confusing at the time of inspection.
- **Concern:** Safety hazard in the event of an emergency when power needs to be turned off quickly.
- **Recommendation:** A licensed electrician should correct the legend so it's accurate, complete and legible.

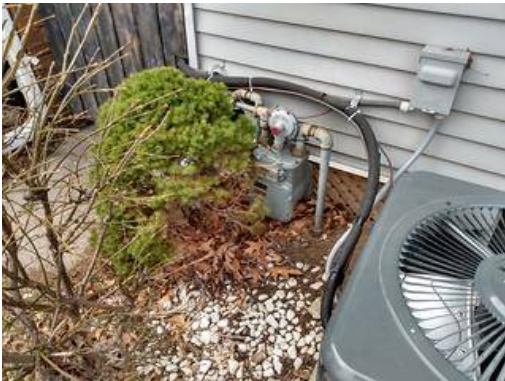
Photo 15-1

15) *Recommendation* - Gas Meter - No Clear Access:

- **Observation / Condition:** Vegetation was overgrown around equipment for one or more utilities such as the gas meter at the time of inspection.
- **Location:** Exterior Right Side (When Facing the Building)
- **Concern:** A minimum clear area of 3 feet all around should exist in front of and on both sides of the meter for maintenance or in case of emergency access.
- **Recommendation:** Vegetation should be pruned or removed as necessary to allow unobstructed access.

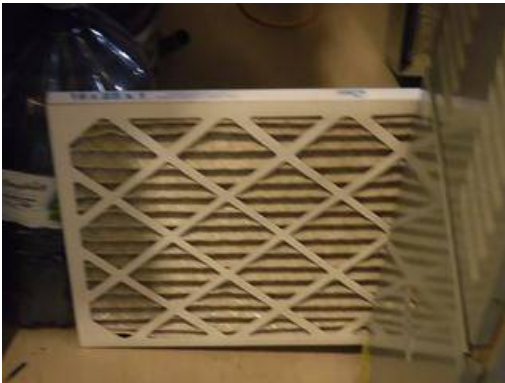
Photo 18-1

18) *Maintain* - Dirty Furnace Filter:

- **Observation / Condition:** The filter to the furnace was dirty at the time of inspection.
- **Concern:** Can cause reduced efficiency of the heating system.
- **Recommendation:** Replace filter every 2-3 months for cleaner air and better energy efficiency.

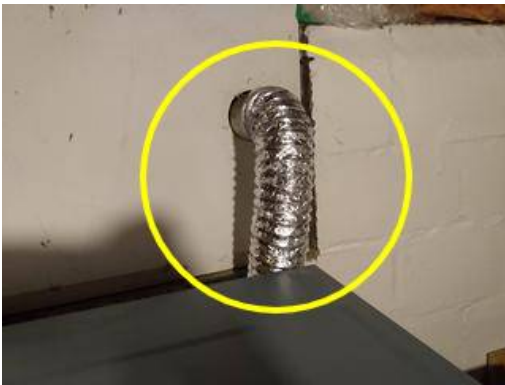
Photo 23-1

23) Safety, Repair/Replace - Dryer Exhaust Duct Material:

- **Observation / Condition:** The clothes dryer duct was a vinyl or mylar, accordion-type, flexible exhaust duct at the time of inspection.
- **Location:** Basement
- **Concern:** Fire Hazard. This type of duct is more likely to accumulate and trap lint and are susceptible to kinks or crushing, which can reduce air flow and overheat.
- **Recommendation:** Ducts should be replaced with a rigid or semi-rigid metal duct by a qualified contractor.

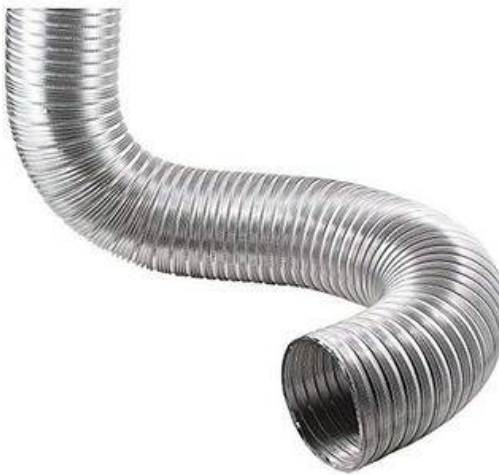
Photo 23-2 Correct Type of Duct (flexible or smooth straight duct)

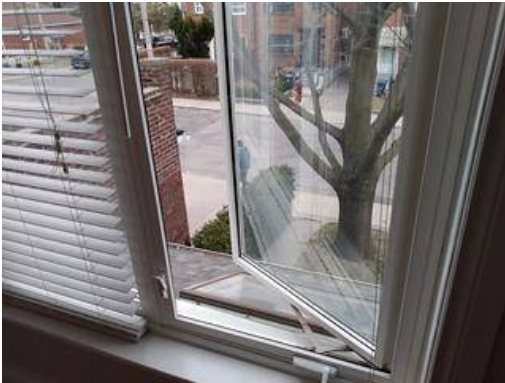
Photo 24-1

24) **Safety, Recommendation** - Missing Screen:

- **Observation / Condition:** One or more windows were missing a screen at the time of inspection.
- **Location:** 2nd Floor Bedroom
- **Concern:** This can be a safety hazard.
- **Recommendation:** A qualified person should install screens.
