Property Inspection Report

Property address: **123 Anywhere Street
Toronto, ON**

Inspection date: **Wednesday, February 3, 2021**

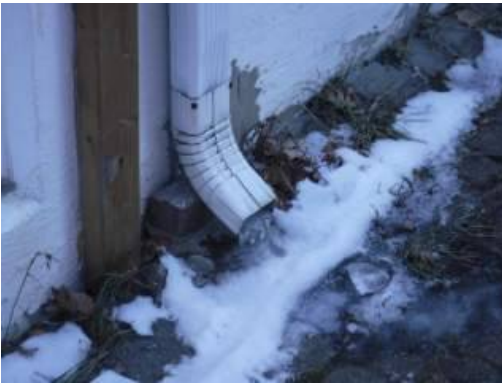
Photo 4-1

4) *Repair/Replace* - Missing Downspout Extensions:

- **Observation / Condition:** Extensions such as splash blocks or drain pipes for one or more downspouts were missing at the time of inspection.
- **Concern:** Water can accumulate around the building foundation and cause foundation / structural damage and basement flooding.
- **Recommendation:** A qualified person should install, replace or repair extensions as necessary so rainwater drains at least 6ft away from the structure.

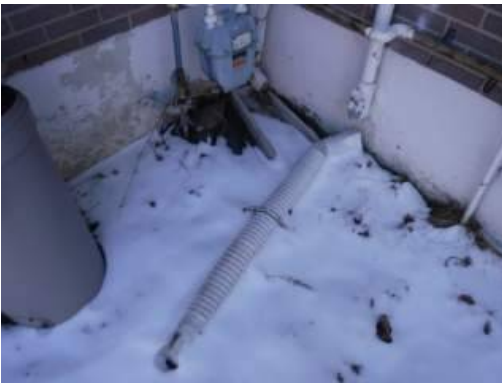
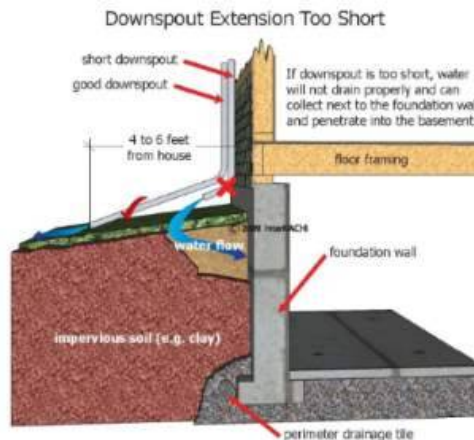
Photo 5-1

5) *Repair/Maintain* - Downspouts Drain Near House:

- **Observation / Condition:** One or more downspouts were shown to drain too close to the home's foundation at the time of inspection.
- **Concern:** This can result in excessive moisture in the soil at the foundation, which can lead to foundation/structural movement and possible basement flooding .
- **Recommendation:** A qualified roofing contractor should adjust downspout extensions to drain at least 6 feet from the foundation.

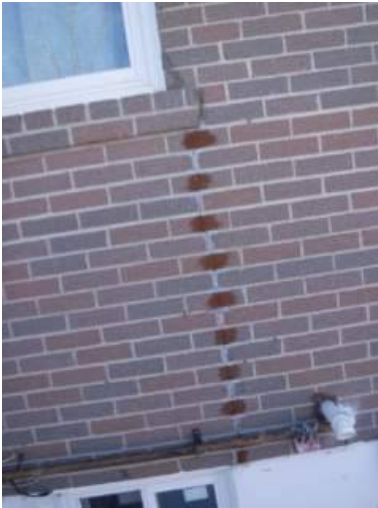
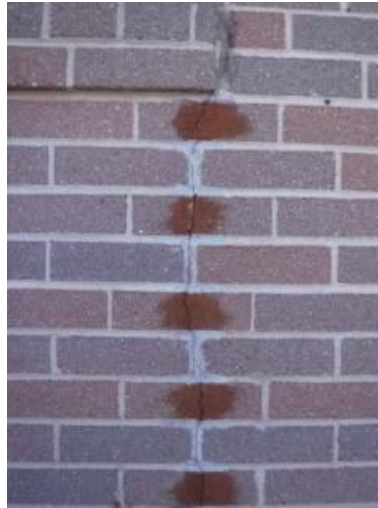
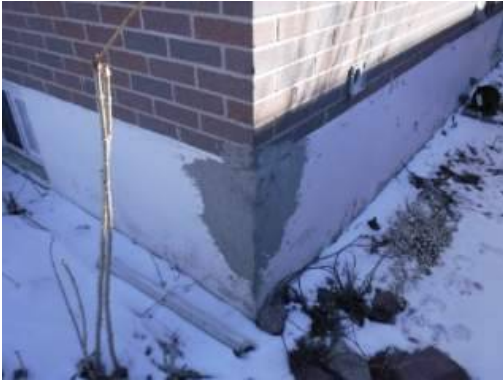
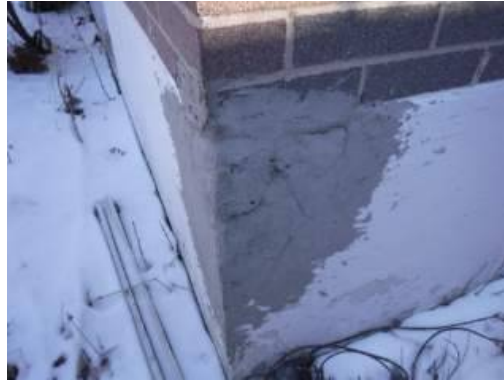
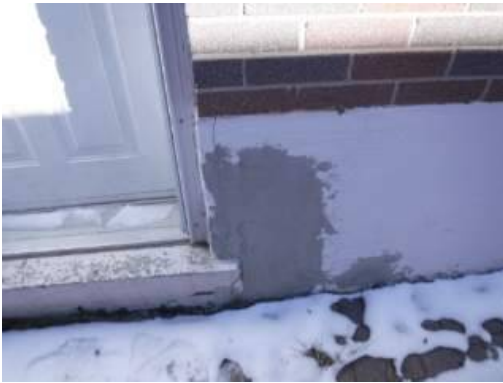
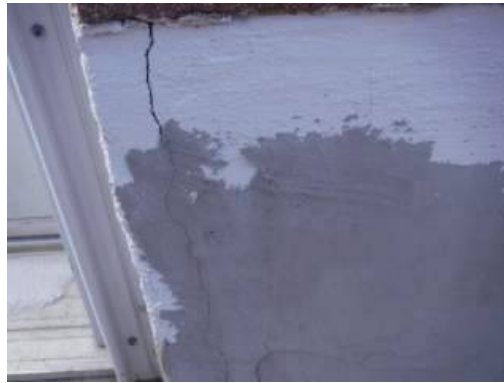
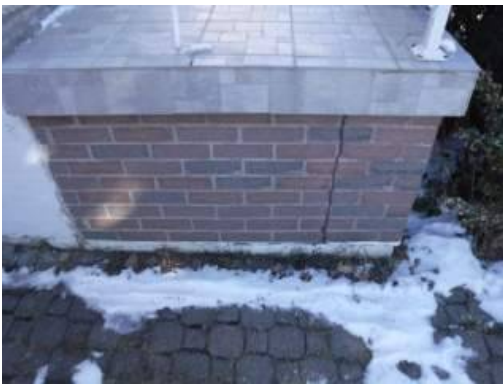
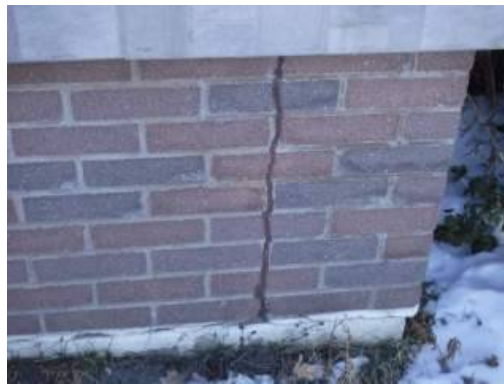
Photo 8-1

8) Major Defect, Repair/Replace - Major Deterioration, Foundation Failure:

Observation / Condition: Major cracks or areas with damage were found in the masonry (brick or stone) veneer and foundation at the time of inspection.

Concern: May indicate that settlement has occurred and/or that the foundation has failed.

Recommendation: A qualified contractor should repair the damaged masonry veneer to prevent water from entering wall cavities and causing mold, fungal rot or structural damage. Consult with a qualified engineer to determine if foundation repairs are needed, and/or if settlement is ongoing.

Any such repairs should be made by a qualified contractor. Such contractors and engineers may include:

- Foundation repair contractors who may prescribe repairs, and will give cost estimates for prescribed repairs
- Masonry contractors who repair and/or replace brick veneer
- Geotechnical engineers who attempt to determine if settlement is ongoing, and the cause of the settlement
- Structural engineers who determine if repairs are necessary, and prescribe those repairs

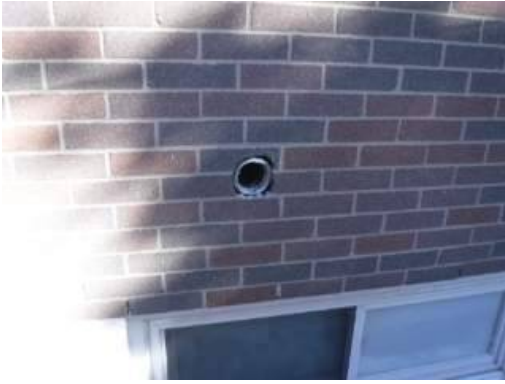
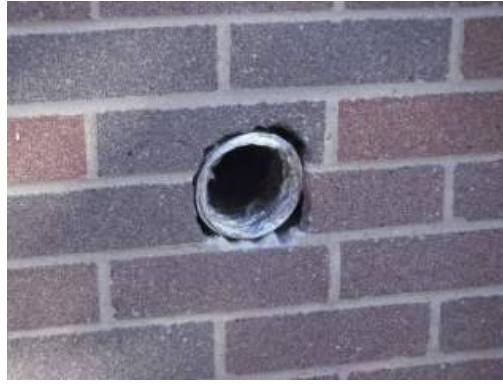
Photo 9-1

9) **Repair/Replace** - Exhaust Duct End Caps - Missing:

- **Observation / Condition:** An exhaust duct end cap was missing at the time of inspection. Their purpose is to prevent unconditioned air from entering the building, and keep out birds, rodents and bugs.
- **Concern:** Blocked ducts can cause fan motors and/or clothes dryers to overheat and can pose a fire hazard.
- **Recommendation:** Recommend that a qualified person repair or replace caps as necessary.

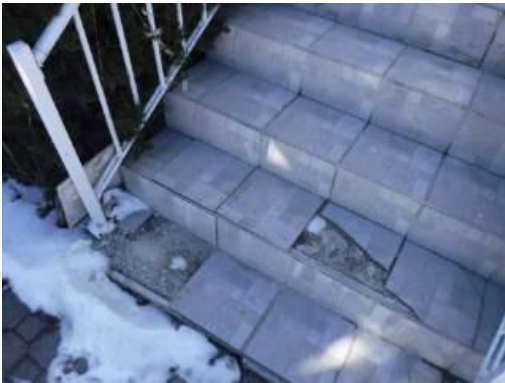
Photo 10-1

10) Repair/Maintain - Stairs - Exterior Front Entrance - Damaged:

- **Observation / Condition:** Some of the stairs at the front entrance were broken and damaged.
- **Concern:** Trip / Fall Hazard. Can cause injury
- **Recommendation:** A contractor should repair

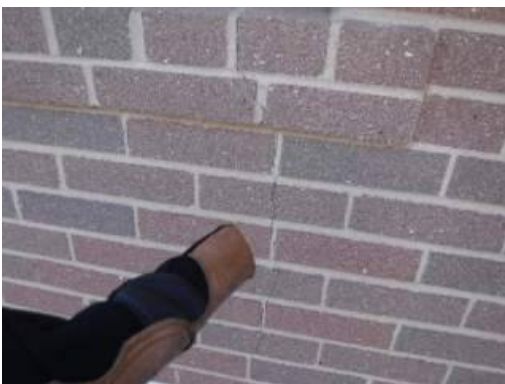
Photo 11-1

11) Monitor - Minor Cracking at Exterior:

- **Observation / Condition:** Siding showed cracking in one or more places at the time of inspection.
- **Concern:** This is a result of temperature changes, and typical as homes with stucco age.
- **Recommendation:** Recommend monitoring.

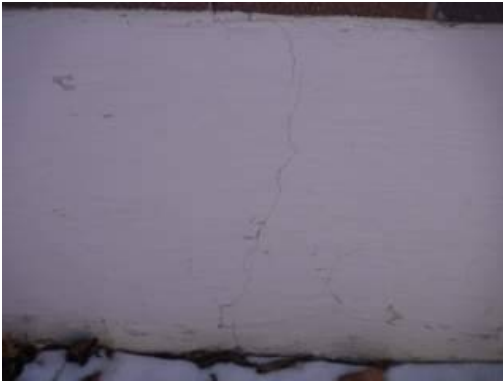
Photo 13-1

13) *Repair/Maintain* - Minor Cracks:

- **Observation / Condition:** Minor cracking was found in the foundation at the time of inspection. These didn't appear to be a structural concern. This is common as concrete ages and shrinkage surface cracks are normal.
- **Recommendation:** Recommend sealing them to prevent water infiltration and monitor them in the future. Numerous products exist to seal such cracks including hydraulic cement, non-shrinking grout, resilient caulks and epoxy sealants.

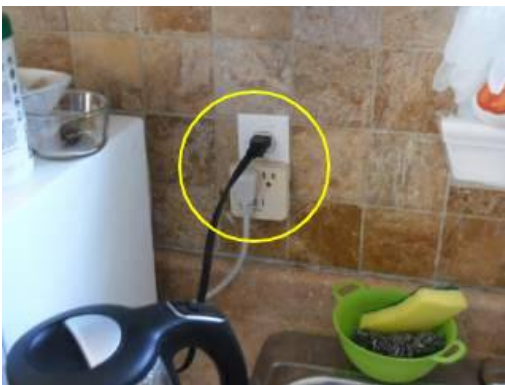
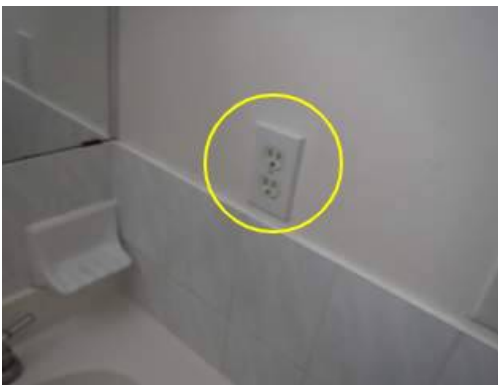
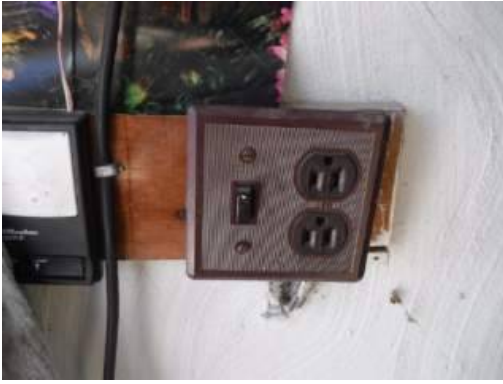
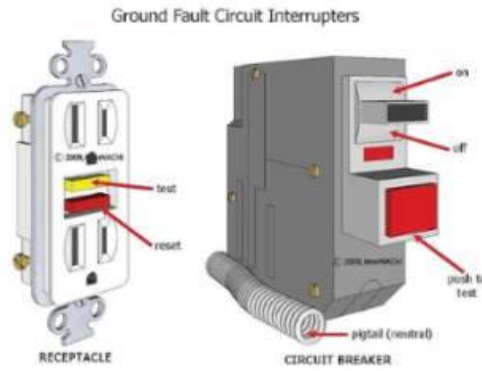
Photo 16-1

16) Safety, Repair/Replace, Evaluate - Missing GFCI Outlets:

Observation / Condition: Electric receptacles (outlets) at the kitchen / bathroom(s) / garage / exterior & basement had no visible ground fault circuit interrupter (GFCI) protection, or the inspector was unable to determine if GFCI protection was present at the time of inspection.

Concern: If not GFCI-protected, outlets in wet areas pose a shock and fire hazard.

Recommendation: A licensed electrician should evaluate and install GFCI protection.

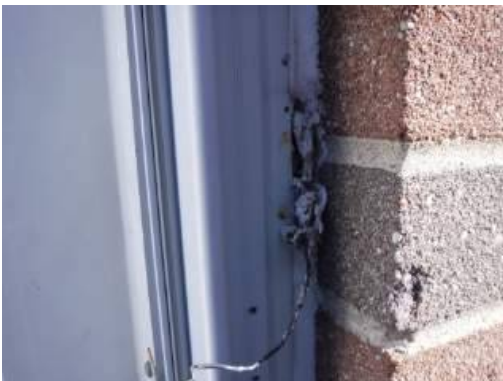
Photo 18-1

18) **Safety, Repair/Replace, Evaluate** - Substandard Wiring Found:

- **Observation / Condition:** Substandard wiring was found at the [building exterior].
- **Concern:** This is a safety hazard.
- **Recommendation:** A licensed electrician should evaluate and repair as necessary and per standard building practices.

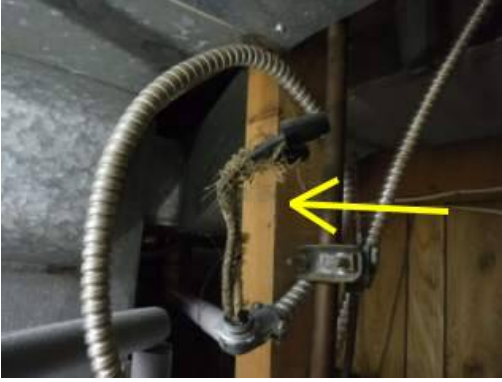
Photo 19-1

19) **Safety, Repair/Replace** - Frayed / Damaged / Deteriorated Wiring:

- **Observation / Condition:** Wiring and/or related components in the utility room by the water heater appeared to be frayed / damaged or deteriorated.
- **Concern:** This is a fire hazard.
- **Recommendation:** Recommend that a licensed electrician repair as necessary.

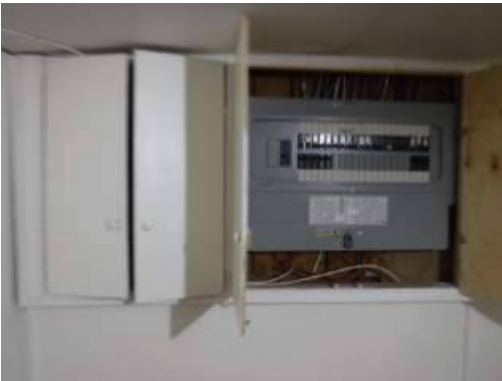
Photo 20-1

20) Repair/Replace, Evaluate - Main Electric Panel Not Opened:

- **Observation / Condition:** The inspector was unable to open and evaluate the main service panel(s) because it was located in a cabinet at the time of inspection without adequate working space.
- **Concern:** The condition of the panel(s) is unknown and is excluded from this inspection. Repairs may be needed.
- **Recommendation:** A licensed electrician should fully evaluate the main service panel and repair or replace as necessary.

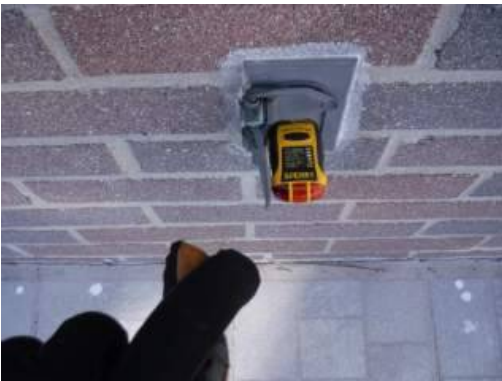
Photo 21-1

21) Repair/Replace, Evaluate - No Power:

- **Observation / Condition:** One or more electric receptacles (outlets) at the exterior front entrance appeared to have no power at the time of inspection.
- **Recommendation:** Recommend asking the property owner about this. Switches may need to be operated or GFCI/AFCI protection may need to be reset to make some receptacles energized. If necessary, recommend that a licensed electrician evaluate and repair.

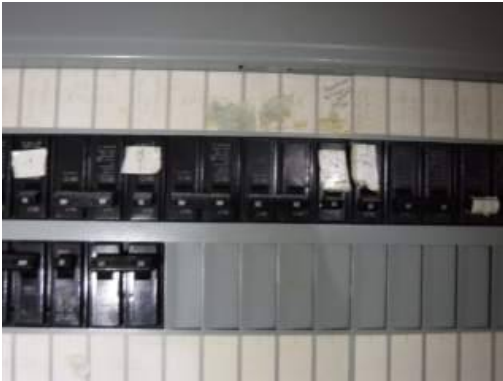
Photo 22-1

22) Repair/Maintain, Evaluate - Legend Missing / Substandard:

- **Observation / Condition:** The legend for the circuit breakers in the main service panel(s) were illegible at the time of inspection.
- **Concern:** This is a safety / fire hazard in the event of an emergency when power needs to be turned off quickly.
- **Recommendation:** A licensed electrician should correct the legend so it's accurate, complete and legible.

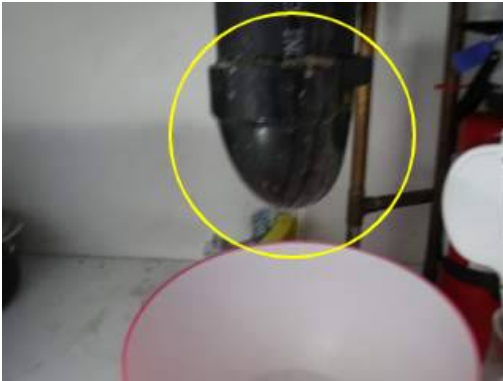
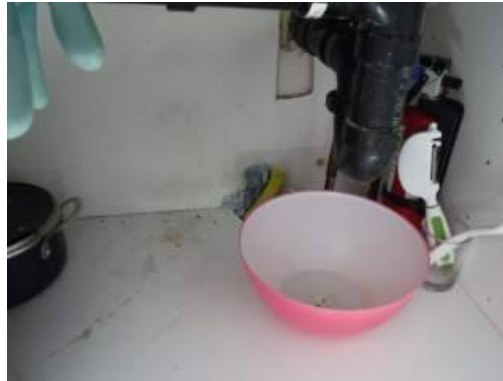
Photo 26-1

26) *Repair/Replace, Evaluate* - Drain, Waste, Vent Pipe - Leaking:

- **Observation / Condition:** A drain waste pipe in the kitchen was leaking at the time of inspection.
- **Concern:** Can cause further damage and possible mold growth.
- **Recommendation:** A licensed plumber should repair or replace.

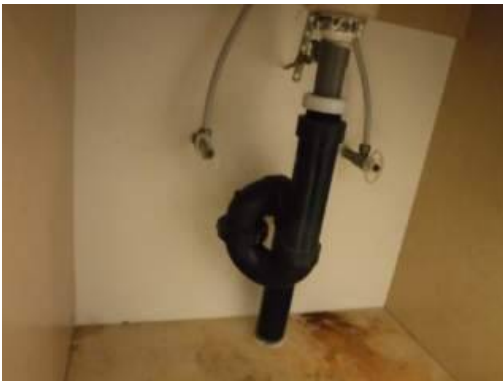
Photo 27-1

27) *Repair/Replace* - Drain, Waste, Vent Pipe - Incorrect Trap (S-Trap):

- **Observation / Condition:** An S-trap rather than a P-trap at the basement sink was installed the time of inspection. This is an incorrect installation.
- **Concern:** This is a health hazard. Siphons and sudden flows of water can drain all the water out of the trap, leaving it dry and sewer gases can then enter living areas.
- **Recommendation:** A licensed plumber should repair.

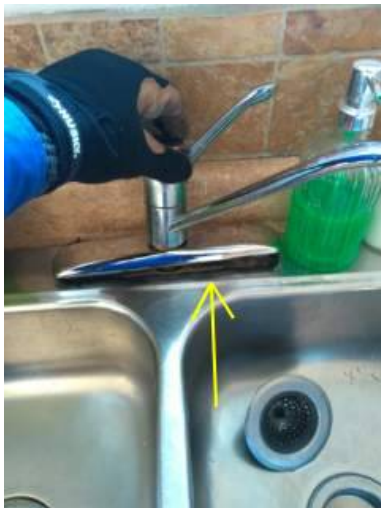
Photo 28-1

28) *Repair/Maintain* - Loose Sink Faucet:

- **Observation / Condition:** The sink faucet was loose at the time of inspection.
- **Concern:** Water can seep into the cabinetry and cause further damage and the potential for mold growth.
- **Recommendation:** A licensed plumber should repair.

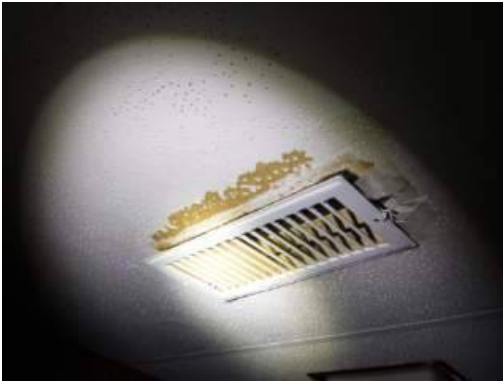
Photo 31-1

31) *Repair/Maintain* - Loose Register:

- **Observation / Condition:** One or more air supply registers were loose or installed in a substandard way at the time of inspection.
- **Recommendation:** A qualified person should repair as necessary so registers are securely attached and are flush with the surface on which they are installed.

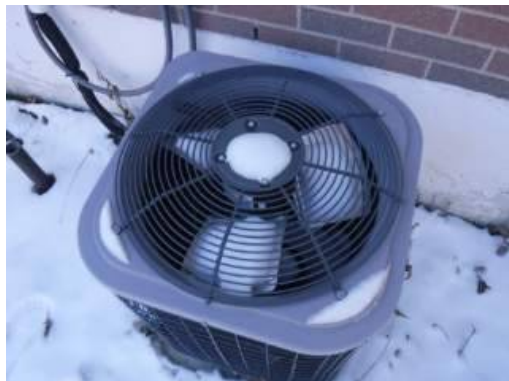
Photo 34-1

34) *Evaluate, Comment* - AC Not Evaluated:

- **Observation / Condition:** The outdoor air temperature was below 60 degrees Fahrenheit (15 degrees celsius) at the time of inspection. The inspector was unable to evaluate the cooling system.
- **Concern:** Air conditioning systems can be damaged if operated during such low temperatures.
- **Recommendation:** A licensed HVAC contractor should inspect and evaluate or contact us to return and perform an inspection of the cooling system.

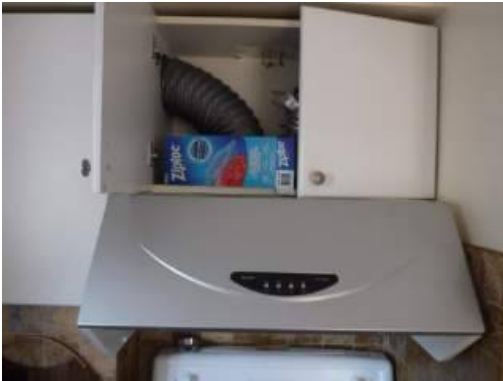
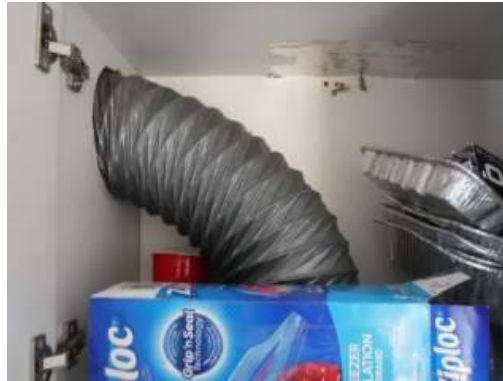
Photo 35-1

35) *Repair/Replace* - Exhaust Range Duct - Incorrect Material.

- **Observation / Condition:** The kitchen exhaust fan duct was a flexible exhaust duct at the time of inspection.
- **Concern:** Fire Hazard. This type of duct is likely to get kinked or crushed and can overheat and cause a fire .
- **Recommendation:** Ducts should be replaced with a rigid or semi-rigid metal duct by a qualified contractor.

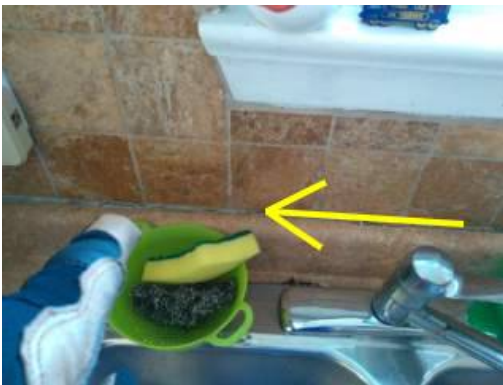
Photo 36-1

36) *Repair/Maintain* - Caulk - Missing or Substandard:

- **Observation / Condition:** Gaps, no caulk, or substandard caulking were found [between countertops and backsplashes/around the sink] at the time of inspection.
- **Concern:** Water may penetrate these areas and cause damage.
- **Recommendation:** Recommend that a qualified person repair as necessary.

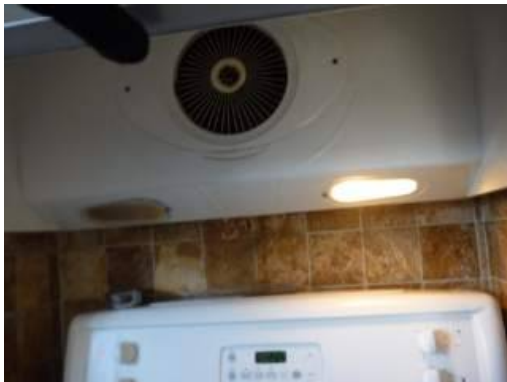
Photo 37-1

37) *Comment* - Kitchen Exhaust Fan Light - Missing / Not Working:

- **Observation / Condition:** One or more light bulbs were missing in the kitchen range hood light fixture at the time of inspection.
- **Recommendation:** Replace light bulb(s) or make repairs by a qualified person if necessary.

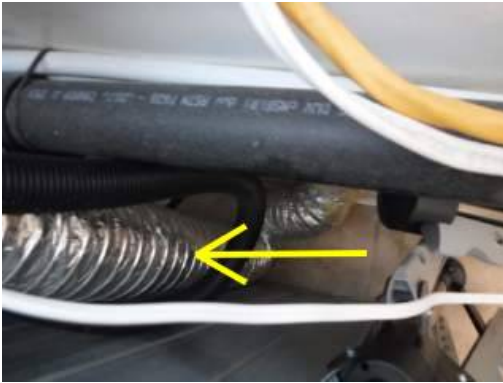
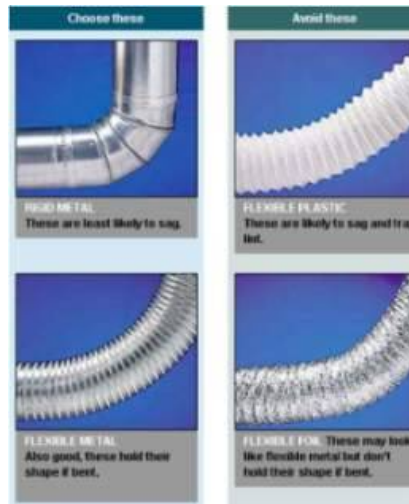
Photo 38-1

38) Safety, Repair/Replace - Dryer Exhaust Duct - Incorrect Material:

- **Observation / Condition:** The clothes dryer duct was a vinyl or mylar, accordion-type, flexible exhaust duct at the time of inspection.
- **Concern:** Fire Hazard. This type of duct is more likely to accumulate and trap lint than a smooth metal vent and are susceptible to kinks or crushing, which can greatly reduce the air flow, overheat and cause a fire .
- **Recommendation:** Ducts should be replaced with a rigid or semi-rigid metal duct by a qualified contractor.

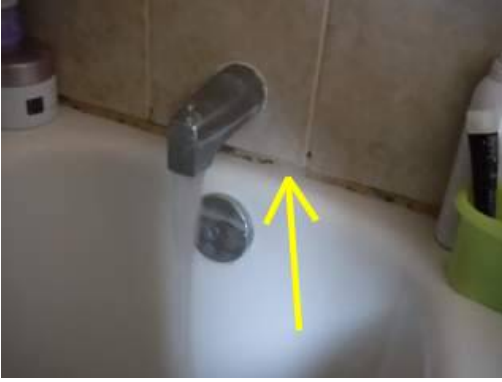
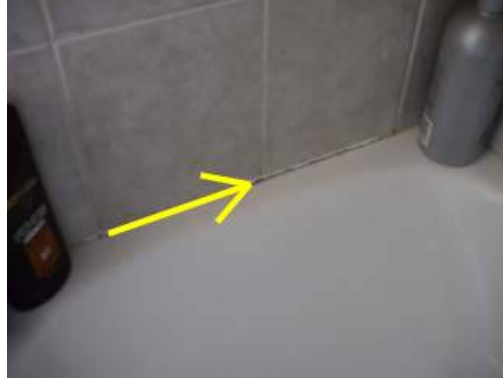
Photo 39-1

39) Repair/Maintain - Missing / Substandard Caulk - Bathtub:

- **Observation / Condition:** Gaps, no caulk, or substandard caulking were observed between the bathtub and the walls in the main floor bathroom at the time of inspection.
- **Concern:** Water may penetrate these areas and cause damage and possible mold growth.
- **Recommendation:** A qualified contractor should repair.

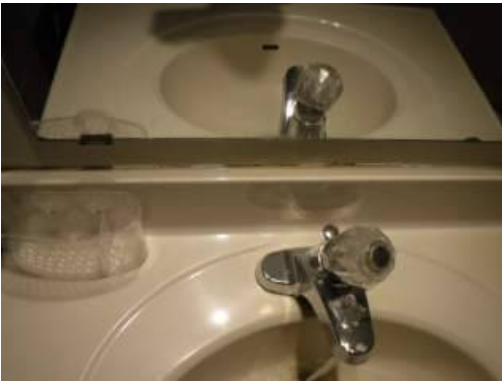
Photo 40-1

40) Repair/Maintain - Caulk - Missing or Substandard:

- **Observation / Condition:** Gaps, no caulk, or substandard caulking were found [between countertops and backsplashes / around the sink] at the basement bathroom at the time of inspection.
- **Concern:** Water can penetrate these areas and cause damage and the potential for mold growth.
- **Recommendation:** A qualified contractor should repair as necessary.

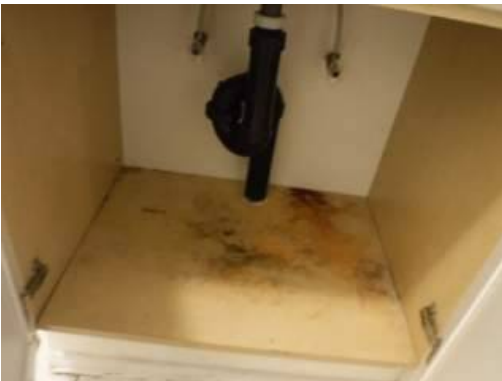
Photo 41-1

41) Evaluate - Water Stains - Below Sink:

- **Observation / Condition:** Stains were found in the shelving or cabinets below the sink at the time of inspection.
- **Concern:** Plumbing leaks may have occurred in the past and can happen in the future.
- **Recommendation:** Consult with the property owner about this, and if necessary a qualified person evaluate and repair.

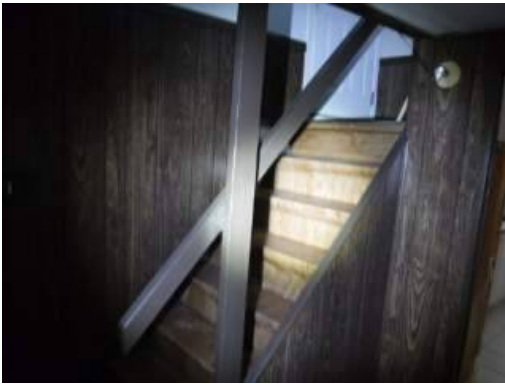
Photo 45-1

45) **Safety, Repair/Replace** - Unsafe Open Railing:

- **Observation / Condition:** Guardrails / Handrails leading to the basement were too large at the time of inspection. Guardrails should not have gaps or voids that allow passage of a sphere equal to or greater than 4 inches in diameter between stair edges and guardrails.
- **Concern:** This poses a safety hazard. (e.g. falling through)
- **Recommendation:** A qualified contractor should repair or replace guardrails for safety.

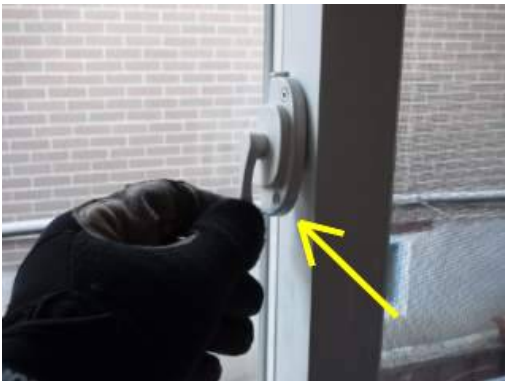
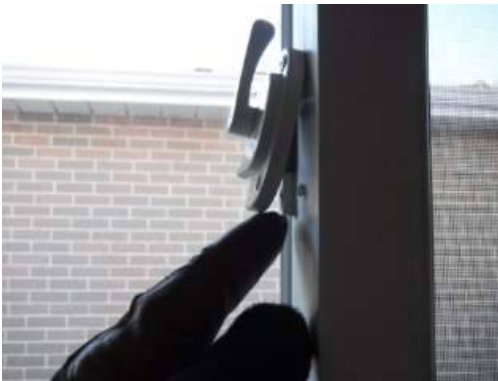
Photo 46-1

46) **Repair/Replace** - Window Locks - Broken / Loose:

- **Observation / Condition:** Lock mechanisms on one or more windows in the kitchen were loose at the time of inspection.
- **Concern:** This can pose a security risk.
- **Recommendation:** Recommend that a qualified person repair as necessary.

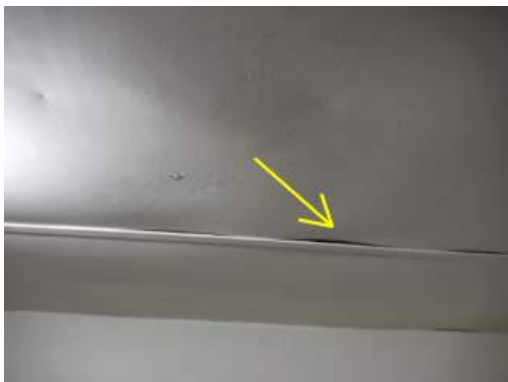
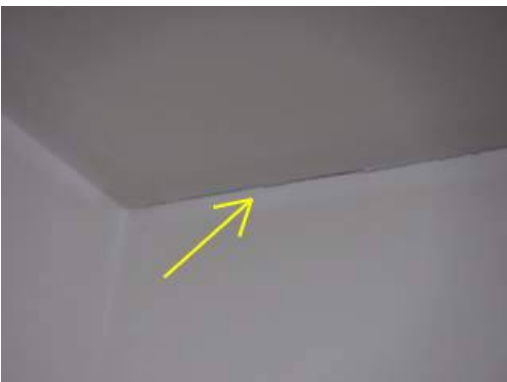
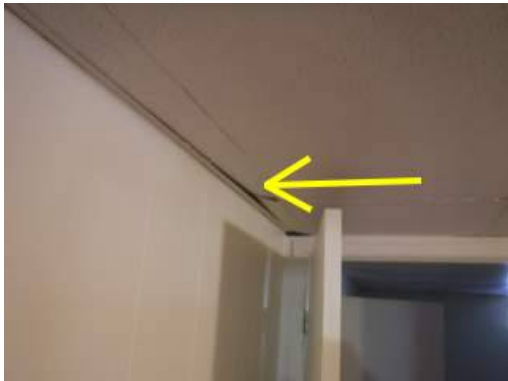
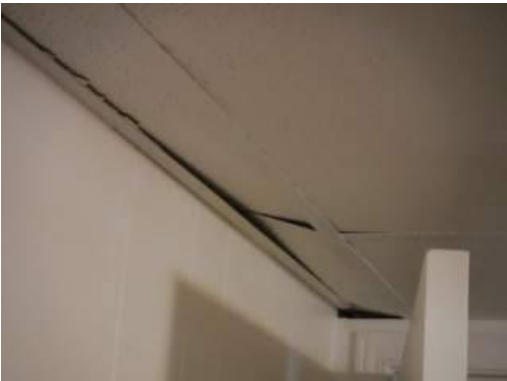
Photo 47-1

47) **Repair/Replace** - Ceiling Damage:

- **Observation / Condition:** Walls and ceilings were damaged and/or were cracked in the basement at the time of inspection.
- **Recommendation:** Recommend that a qualified person repair as necessary.

**Cause unknown. Recommend asking the seller and/or having a qualified contractor further evaluate and repair.

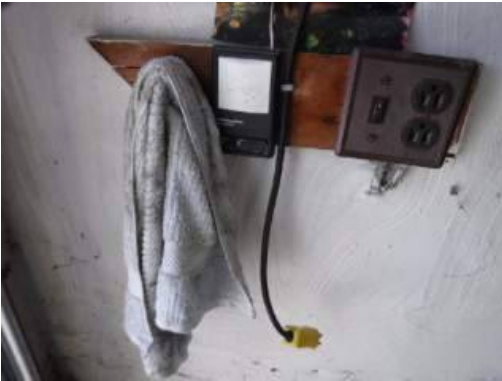
Photo 48-1

48) Repair/Replace - Inoperable Wall Switch: Garage Vehicle Door

- **Observation / Condition:** Garage wall switch was inoperable at time of inspection.
- **Recommendation:** Recommend testing the wall switch and possible replacement.

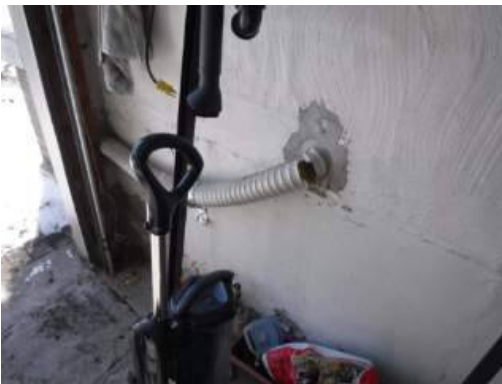
Photo 49-1

49) Repair/Maintain - Duct - Damaged:

- **Observation / Condition:** There was an exhaust duct located in the garage which was damaged at the time of inspection.
- **Concern:** Safety hazard due to the risk of fire. Air flow will be restricted as a result.
- **Recommendation:** A qualified contractor should replace or repair.

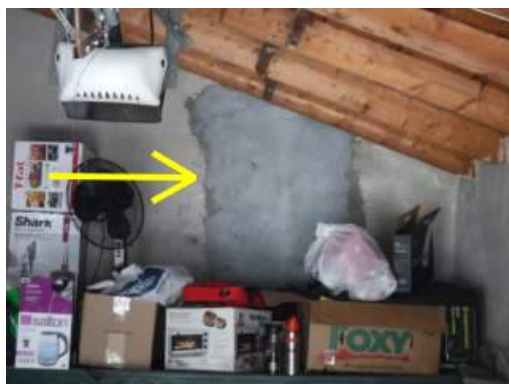
Photo 50-1

50) Evaluate - Garage Wall Repair:

- **Observation / Condition:** There appeared to be some repair work previously done at the back wall in the garage.
- **Recommendation:** Consult with the homeowner as to the cause and reason for the repair. Further evaluation may be required.
